# **Fundamentals for Remote Structural Health Monitoring of Wind Turbine Blades – a Preproject**

## **Annex E – Full-Scale Test of Wind Turbine Blade, Using Sensors and NDT**

**Ole J.D. Kristensen, Malcolm McGugan, Peter Sendrup,  
Jørgen Rheinländer, Jens Rusborg, Anders M. Hansen,  
Christian P. Debel and Bent F. Sørensen**

**Abstract** A 19.1 metre wind turbine blade was subjected to static tests. The purpose of the test series was to verify the abilities of different types of sensors to detect damage in wind turbine blades.

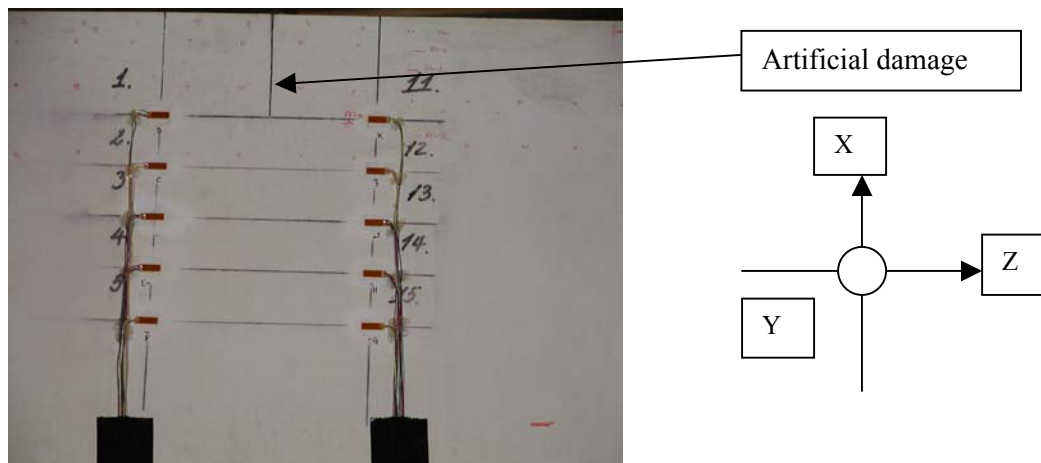
Figure 7. Up-wind surface of blade, damage no. 1. Tip-end direction to the right.

The size of the initial damage was determined to 98 mm and ended just before the line of the two strain gauges closest to the trailing edge, see Figure 6 and Figure 7. The SG numbering is made as lowest numbers on up-wind surface, and lowest numbers nearest to the root intersection.

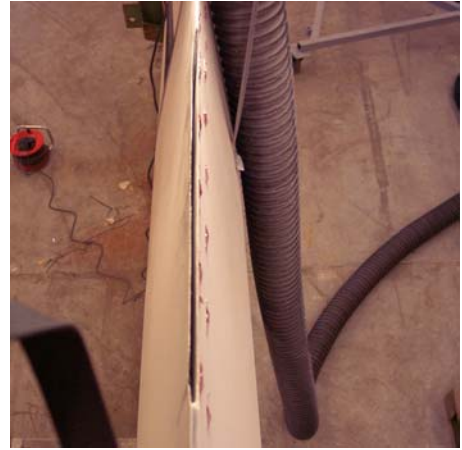
The second damage was a removal of the glue in the joint in the trailing edge. An angular grinder was used to remove the glue. All glue in the trailing edge joint was removed over a distance of 0.40 meter. The artificial damage was made in a position 11 metres from the root intersection. Due to the slim size of the trailing edge the blade chord was shortened a little when the glue was removed, see Figure 11 and the trailing edge of up-wind and down-wind shells became very thin where the damage was made.

Figure 12. Damaged trailing edge

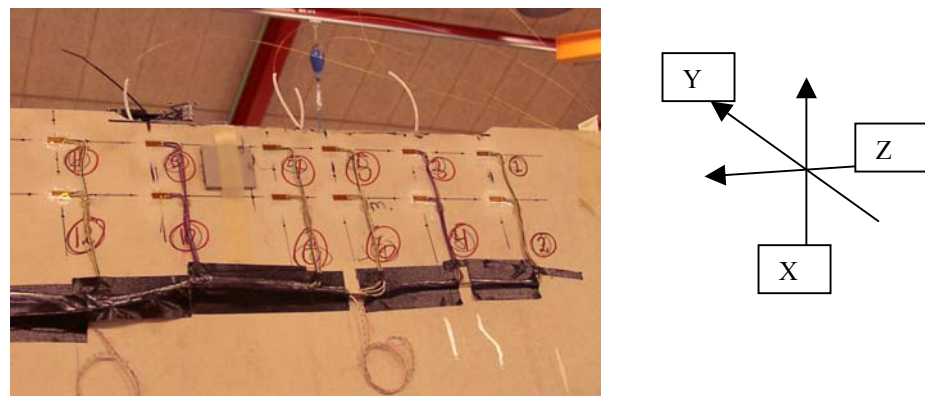
*Figure 18. Down-wind surface of blade, damage no. 2. Tip-end direction to the left.*

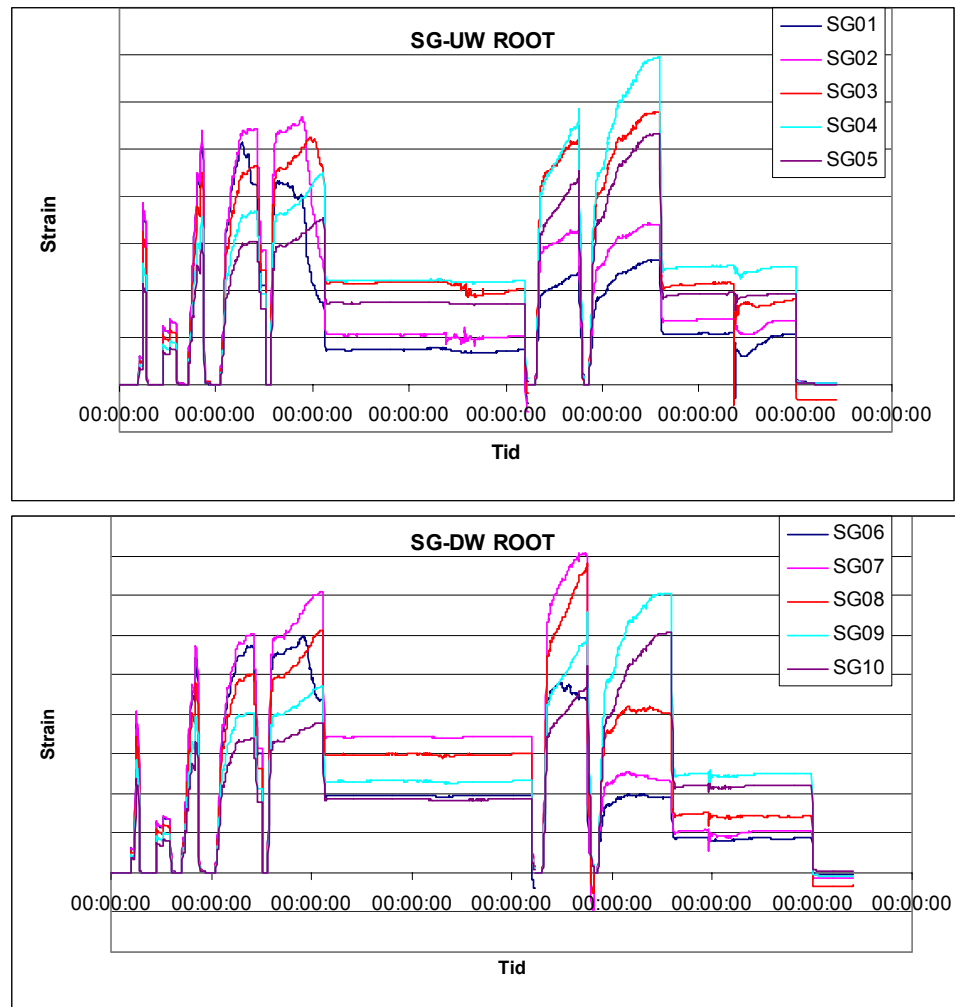
Figure 26. SG-measurements from test WING001 – WING008, Damage no. 1.

As the load was applied to the blade a linear related increase in strain level was measured on all the strain gauges. The relation in strain level between the strain gauges was also linear in correspondence to the distance from the neutral line of the blade, except for the 4 strain gauges (SG-no. 1, 6, 11, 16) in the line of the tip of the damage, which showed a lower strain level. The linearity ruled for tests “WING001 to “WING003”. During test “WING004” the strain level for the gauges (SG-no. 1, 6, 11, 16) nearest the trailing edge decreased while the next gauges (SG-no. 2, 7, 12, 17) were increasing in strain level, this change is indicated in the red arrows in Figure 26. The change in strain level was highest on the up-wind side of the blade; this corresponds with the growth of the damage during this test. This change in strain level between the strain gauges corresponded to the propagation in the crack length.

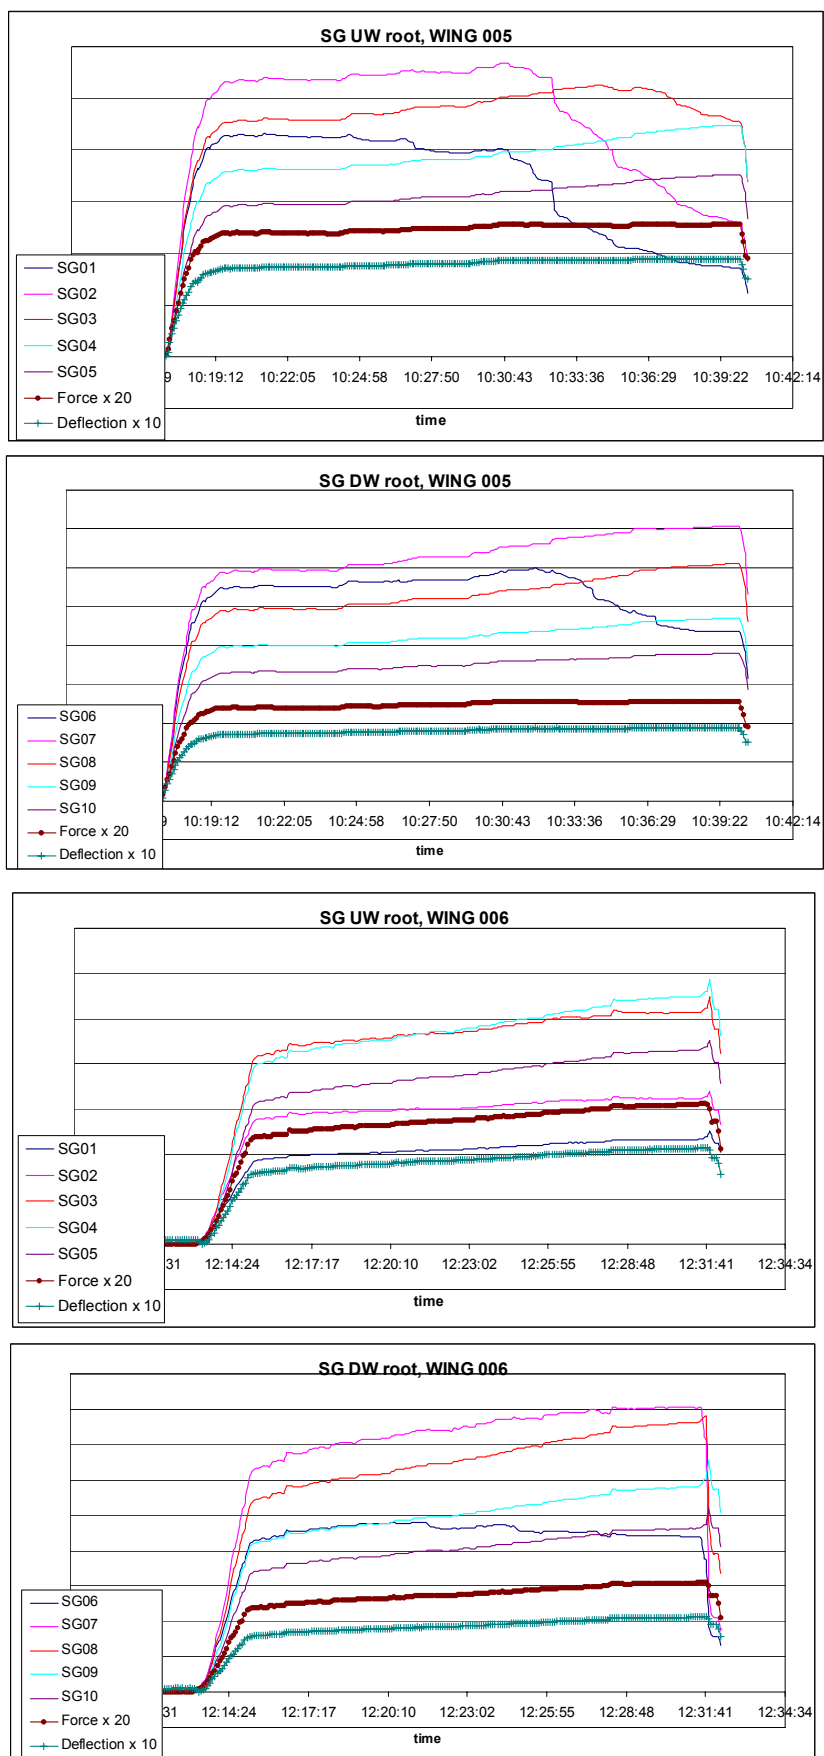
The major difference between WING005 and WING006 is the duration of the crack propagation. During WING 005 the crack propagated over a little less than 10 minutes, and during WING 006 the same size of damage propagation happened within the same minute. This is seen as a very steep change/decrease in the strain level for strain gauge no. 08 at the end of WING 006. Note, that the decrease in strain level appears prior to the unloading/decrease in load level.

Figure 33. Strain measurements during WING 005 and WING 006

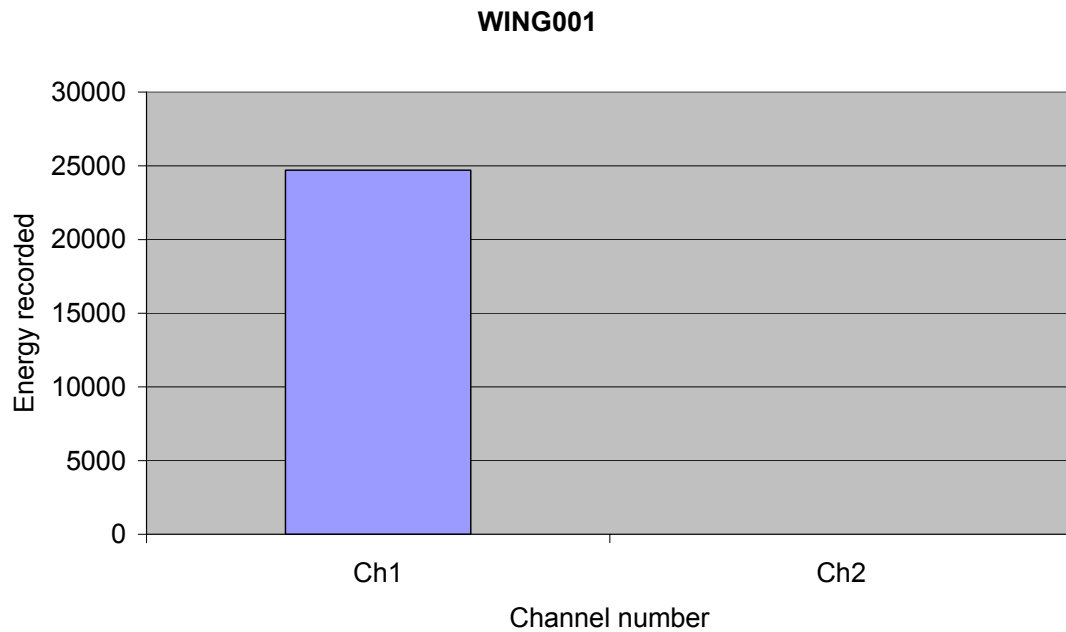
Here one sensor (channel 1) was placed directly adjacent to the initiator crack and the other was placed at a point on the structure far from any anticipated sources. This short test (WING001) lasted only 13 minutes and produced no actual crack growth; in fact it produced no damage detectable with either visual inspection or ultrasonic and X-ray NDT. However the AE sensor placed adjacent to the crack initiator recorded 1949 AE hits with a total energy content of 24027, (Figure 34), while the sensor (channel 2) placed away from the crack initiator recorded no activity.

This simple test demonstrates the potential of the sensitive AE transducers to monitor events at levels below the severity necessary to cause damage detectable by traditional inspection. It also shows that the test has been successfully designed to preferentially promote damage in the desired location.

Figure 34. Zonal location for WING001

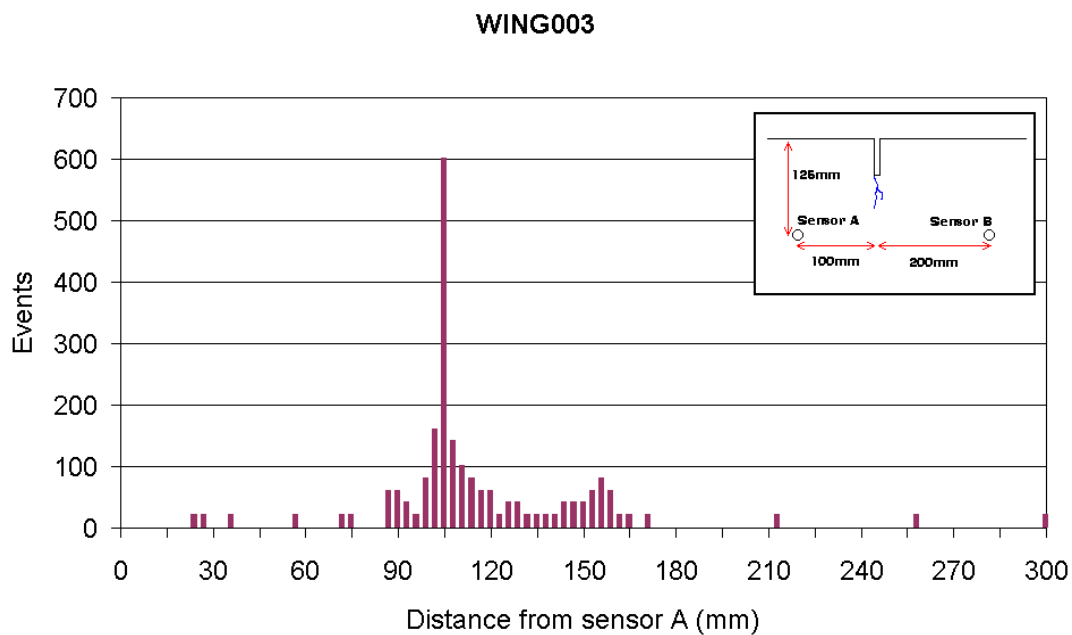
Figure 35. Linear location of AE events for WING003 at end of test

This graph clearly shows a high concentration of AE "events" between the two sensors at precisely the position of the crack.

It is interesting to note in Figure 36 that a second peak has developed to the root side of the main source corresponding to the crack tip. Indeed this secondary source is the more active at the beginning of the test. The presence of this secondary source is also discernible, although not so strongly, in Figure 35. Photographs subsequently taken of the damage shows crack branching on the downwind side that is in agreement with a secondary source.

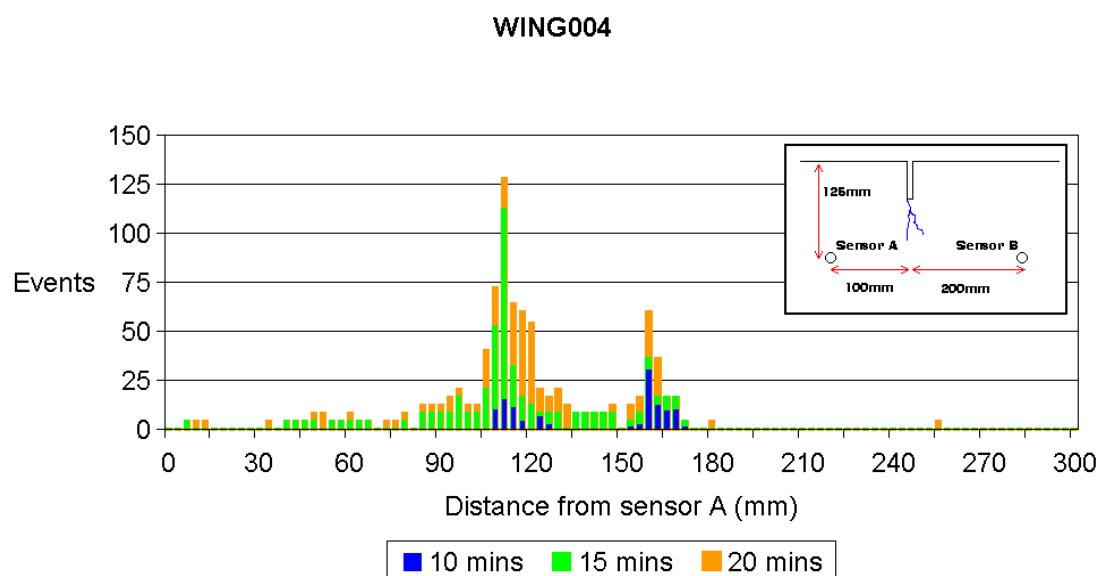
*Figure 36. Linear location of AE events over time in WING004*

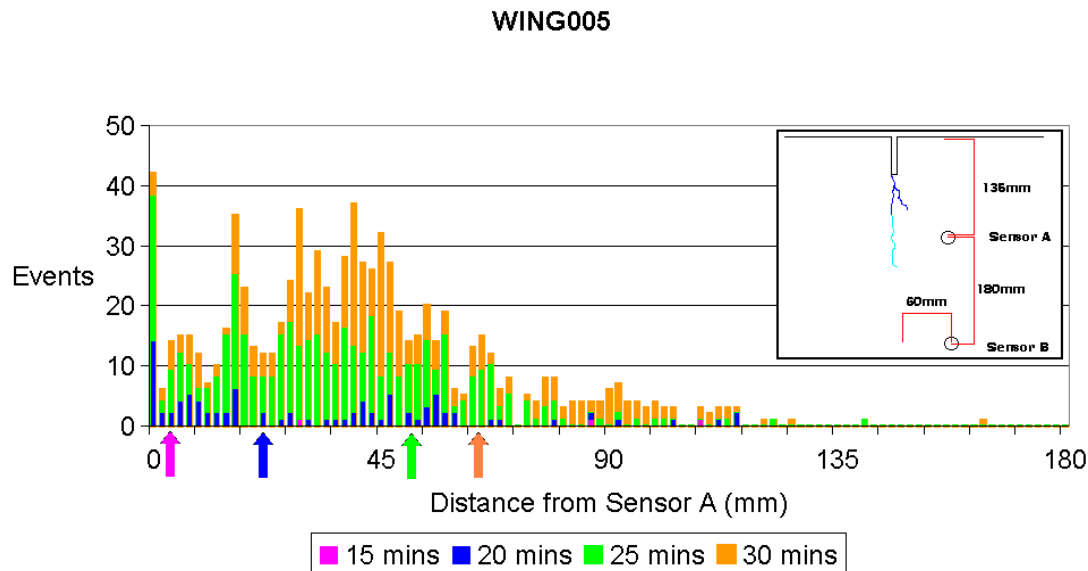
Figure 37. Linear location of AE events over time in WING005 (arrows indicate crack tip positions taken from video images)

During this test the crack advanced 81mm on the upwind side, where the AE sensors were positioned. During the early part of this test the crack front was above the sensor array, and as the graph shows very few hits were recorded by the location array during this time. However, as the crack moved downwards into the area monitored by the sensors (from the left in this graph) the AE events become more frequent and track to the right as the crack advances. The general location of the crack front at four time intervals and the graph display at that time are indicated by colour coding.

It is clear from Figure 37 and Figure 38 that the AE events are not only being generated at the cracktip, this is agreement with visual observations. In a cracking composite material (unlike metals) the crack wake also contains multiple sources of damage such as fibre pullout. There is therefore *a long damage zone*

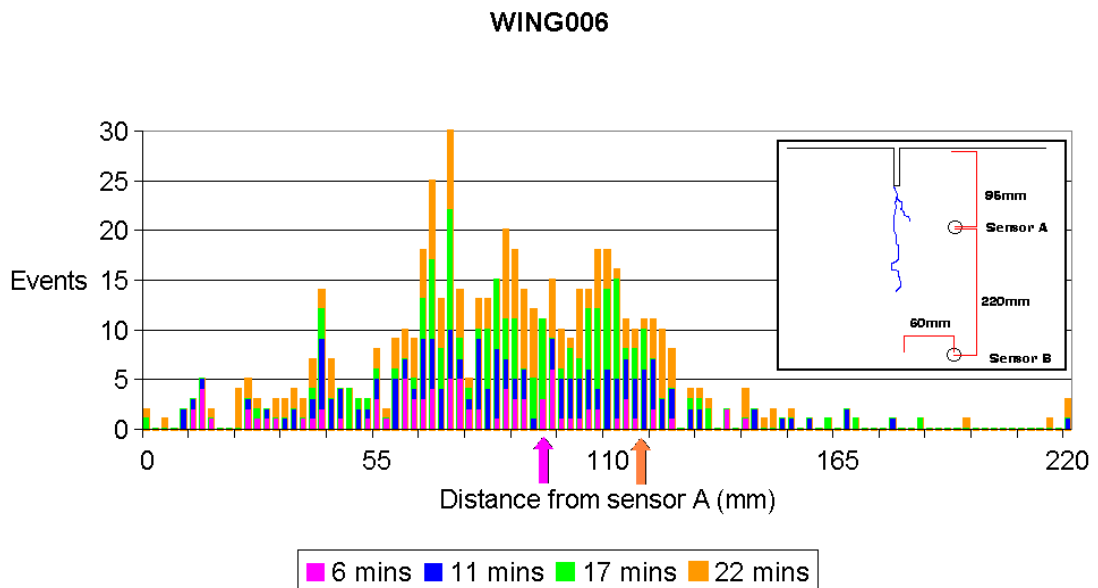
The test was repeated in WING006, but this time the sensors were positioned so that the crack tip began within the monitored area, some 75mm from the sensor nearest the trailing edge. Figure 38 shows a broad source of AE events at the crack tip, it should be noted that the crack advanced only 14mm during this test.

*Figure 38. Linear location of AE events over time in WING006*

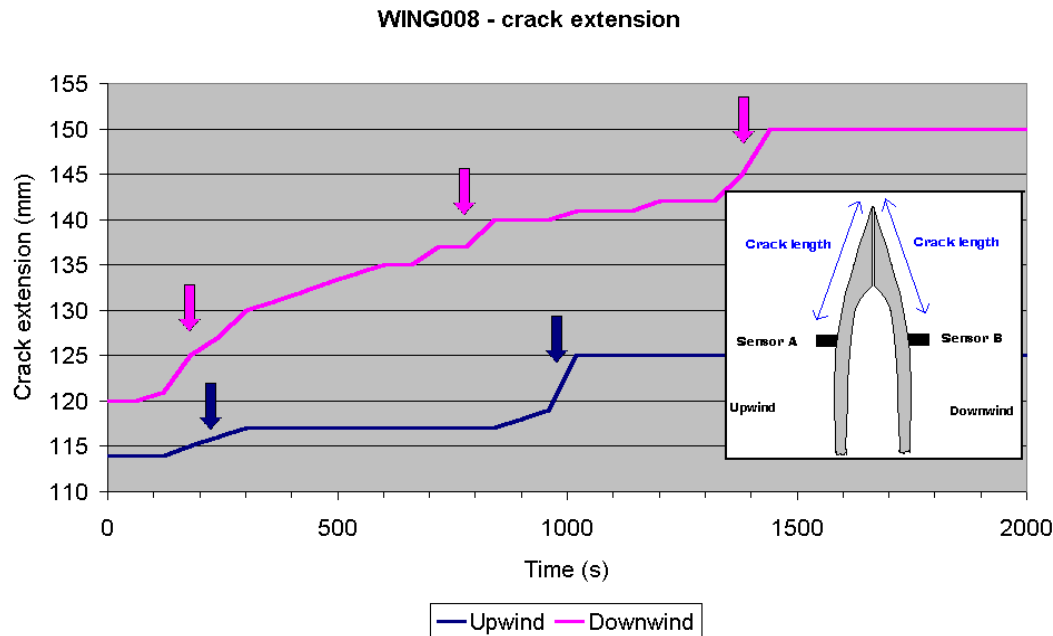
Video images during the test confirmed that the crack advance on each side was not symmetrical. The Upwind (pressure side) crack advanced 11mm during WING008 and the Downwind (suction side) crack advanced 30mm. A rough indication of the crack growth visible on either side of the blade is shown in Figure 39. These readings are only estimates based on viewing of the surface recorded on the test video.

In general the crack growth was at a steady rate, however there are occasions when the crack was seen to grow a few millimetres comparatively quickly. These instances have been highlighted on the graph with colour coded arrows.

Figure 39. Crack extension on either face over time during WING008 test

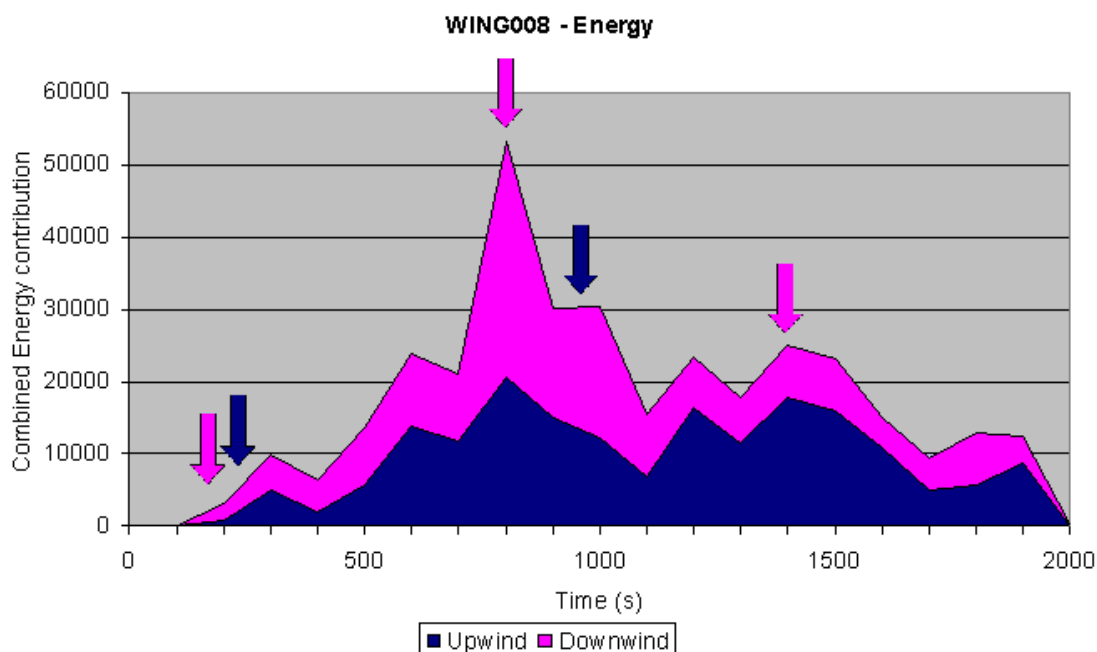
Figure 40 shows the combined energy received by the two AE sensors during the course of WING008. The crack growth indicators established in Figure 39 are shown again here. As might be expected the periods of highest combined energy generally correspond to the periods of crack advance established in Figure 39.

Figure 40. Accumulated energy detected from both sensors during test WING008

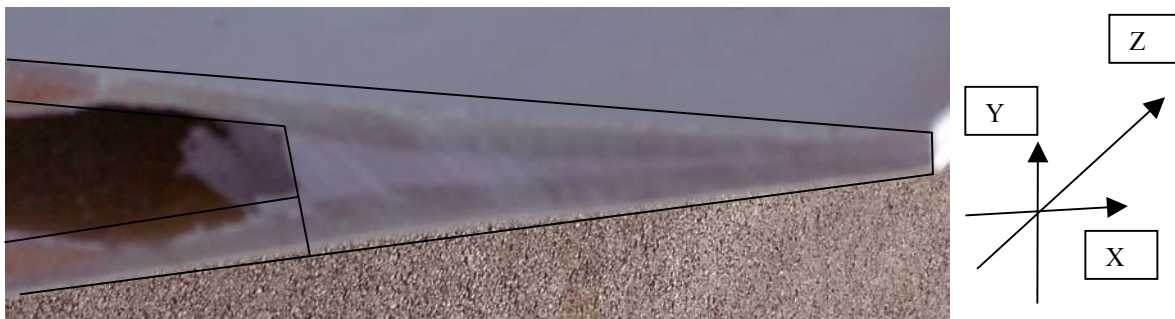
Figure 45. Photo with lines drawn to illustrate the view in the lower part of Figure 44.

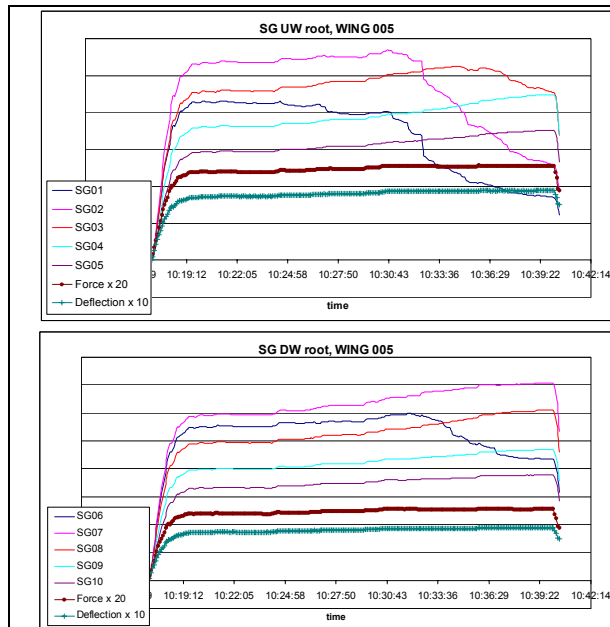
The AE results and the strain gauges measurements show good capability in determining the crack propagation and give good visualisation of the speed of crack propagation. The major growth in crack length during WING005 happens in the last third of the test. This is very visible in the change in strain-level in the strain graph in top of Figure 51. In Figure 52 it is visible that the major part of AE-hits appears in the last third of the test.

Figure 51. Strain development during WING005

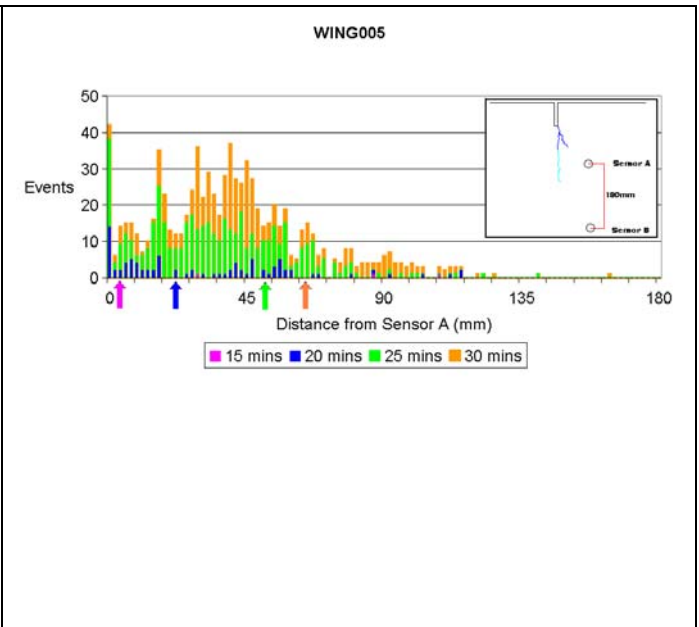
Figure 52. AE-hits vs. time during WING005. Arrows on x-axis shows the distance from crack-tip to sensor A over time.

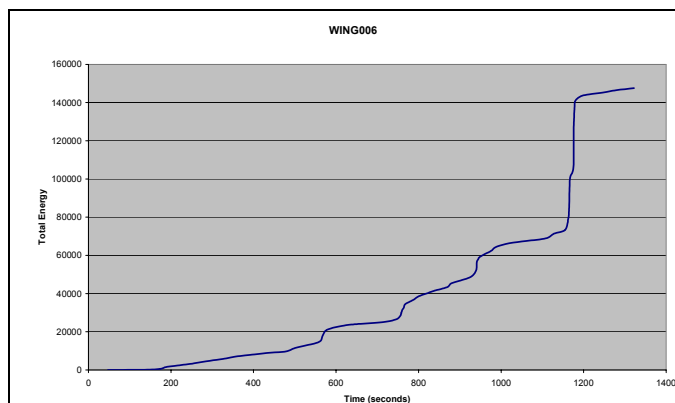
Figure 53. AE-energy measured during WING006

In Figure 53 it is seen that in the very end of test WING006 there is a significant increase in acoustic emission this correlates well with the strain measurements in the lower part of Figure 54. By watching the VCR monitoring of the blade it is seen that the damage propagates very much within a very short period of time in the end of test WING006.

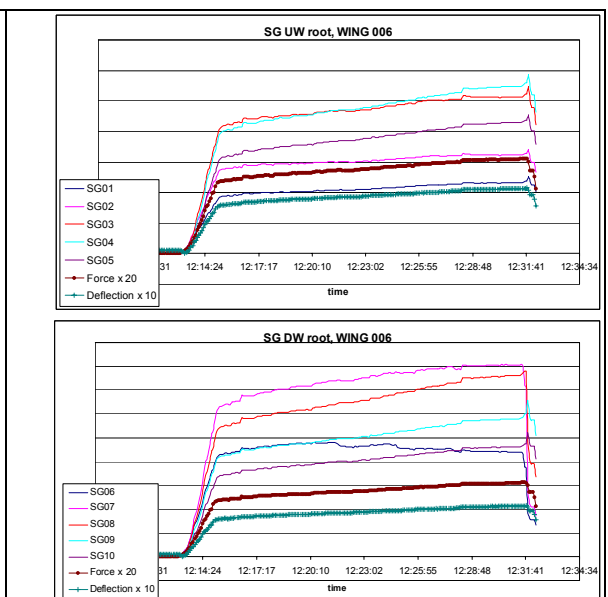
Figure 54. Strain development during WING006

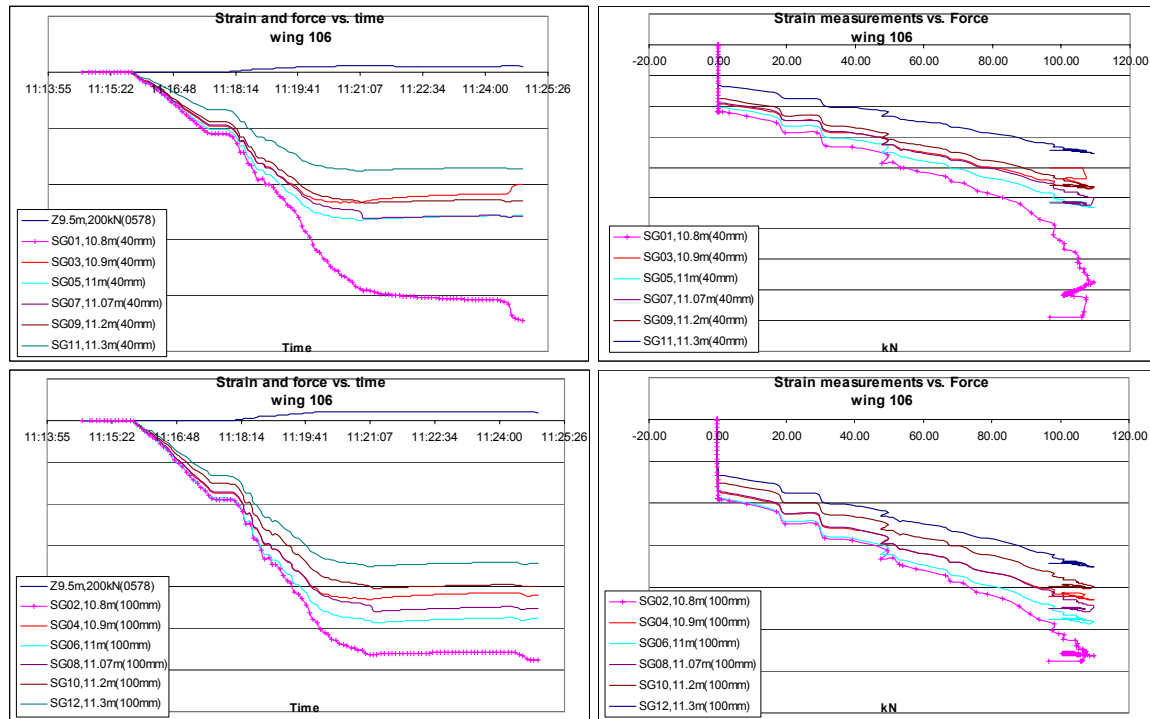
As the load was applied to the blade a linear related increase in strain level was measured on all the strain gauges. The relation in strain level between the strain gauges was also linear in correspondence to the distance from the neutral line of the blade. The linearity ruled for tests “WING 101 to “WING 105”. During test “WING 106” the strain level for gauge no. 3 decreased in strain level as the rest of the gauges were still increasing, see Figure 61.

Figure 61. Measured strain, force and deflection during “WING 106”

This indicates buckling which is also very visible on the video. This buckling in the area of gauge no. 3 appeared in all the tests. The change in strain level between single gauges does not correspond to the crack propagation. It is impossible to determine the crack propagation from the strain gauge measurements.

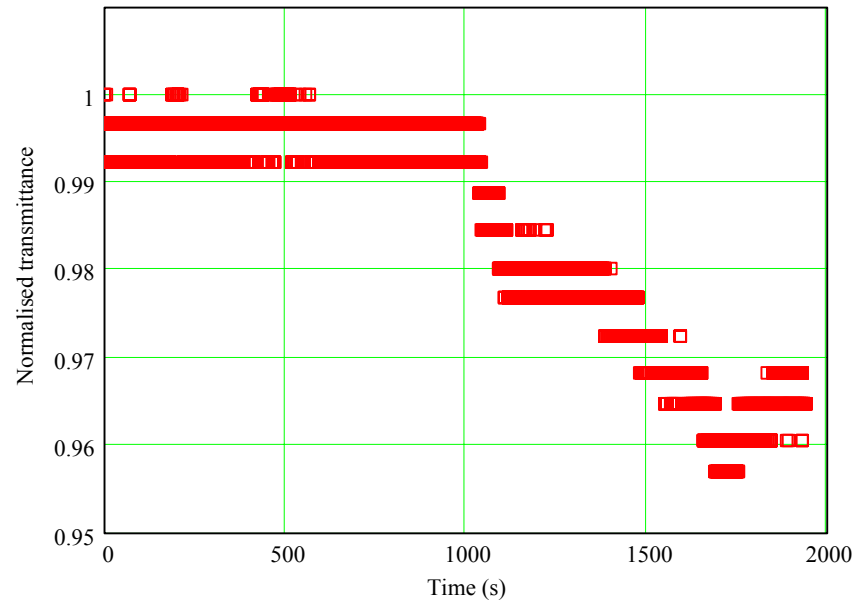
During the first test sequence WING114, there was for the first time a change in the transmittance of the transducer see Figure 62.

Figure 62. Micro bend displacement transducer measurements during WING114

The first 1000 seconds the load on the tip was increased, the load in the centre yoke was gradually increased and the crack started growing. The deformation of the blade had apparently no impact on the transmittance of the transducer. The transducer started to change transmittance at a time when the transducer is reached by the crack tip. The load was still increased, causing a large crack opening, and a still lower transmittance. After 1700 s the load is gradually removed. The entire load was removed after 1900 s. Figure 62 shows that the transducer only partially resumes its initial transmittance. A permanent crack opening is apparently created.

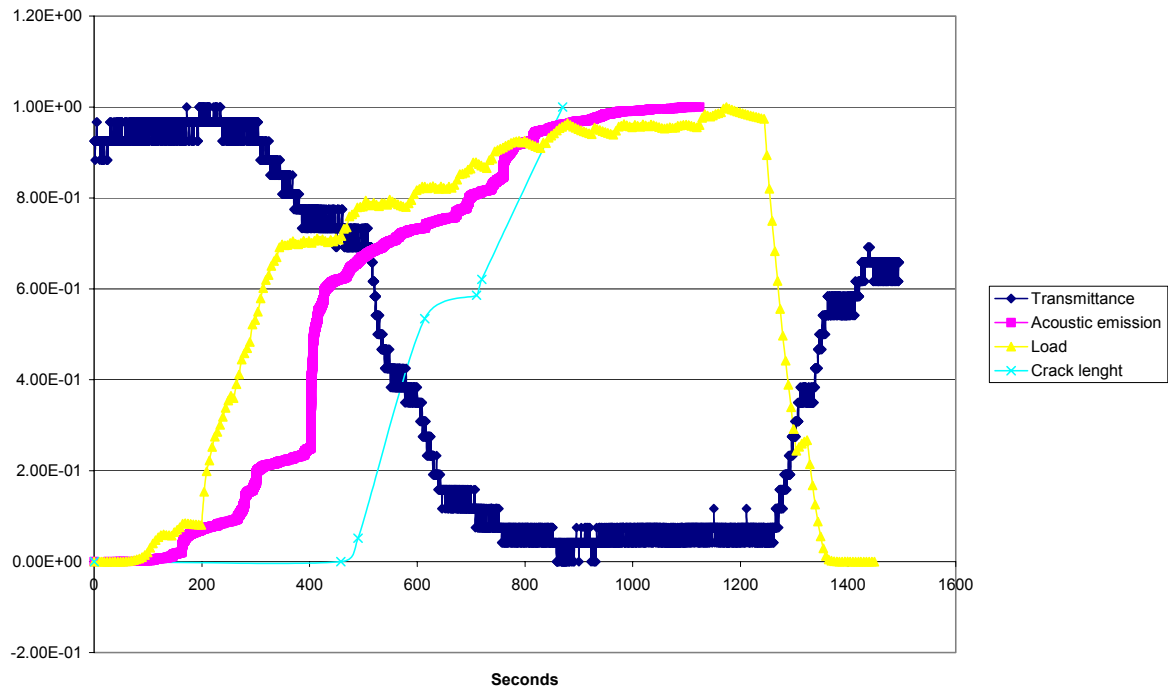
Figure 63. Transmittance of micro bend transducer correlated with normalised values of force, acoustic emission energy and crack propagation during WING115.

In WING115, the load was still more increased with a 10 % decrease in transmittance as a consequence, see Figure 63. The load was increasing until 1200 s, but apparently the deformation of the sensor reached a maximum. After 1200 s the load is removed and the transducer resumes most of its original transmittance.

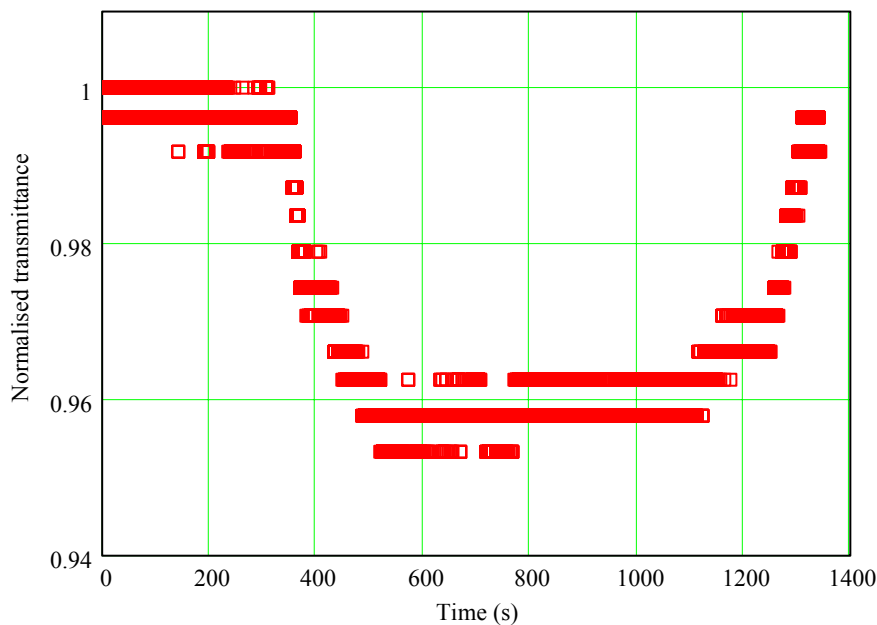
Figure 64. Micro bend transducer signal during WING116

Figure 64 shows, the transmittance decreases once more, but only a few percent, even though the crack with almost certainty passed the transducer, and the gap was large. The transmittance did not fall to zero, as expected for a crack width larger than 200  $\mu\text{m}$ .

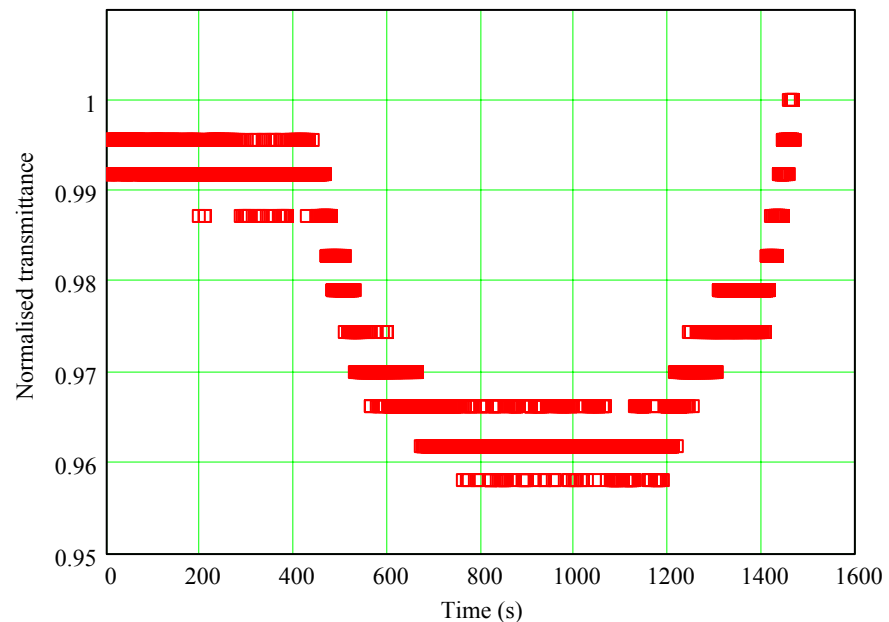
Figure 65. Micro bend transducer signal during WING117

This new test was apparently a repetition of the test before. There was a decrease in transmittance until a certain point. The crack had now passed the transducer and the crack was at maximum load several mm wide. A blade was inserted in to the crack, at the location of the transducer, and pushed to the bottom of the adhesive region. There was no detectable contact between the transducer and one of the shells. The crack was in the interface between one of the shells and the adhesive layer and the transducer was fully contained in the adhesive. The surface, which initially was glued to the shell, was now almost completely loosened. This conclusion was reached after direct visual inspection, through the crack opening, and by use of a blade. The change of transmittance indicates that there was some contact, but maybe only through a number of loosened glass - fibres, that had been torn out of the fibreglass composite.

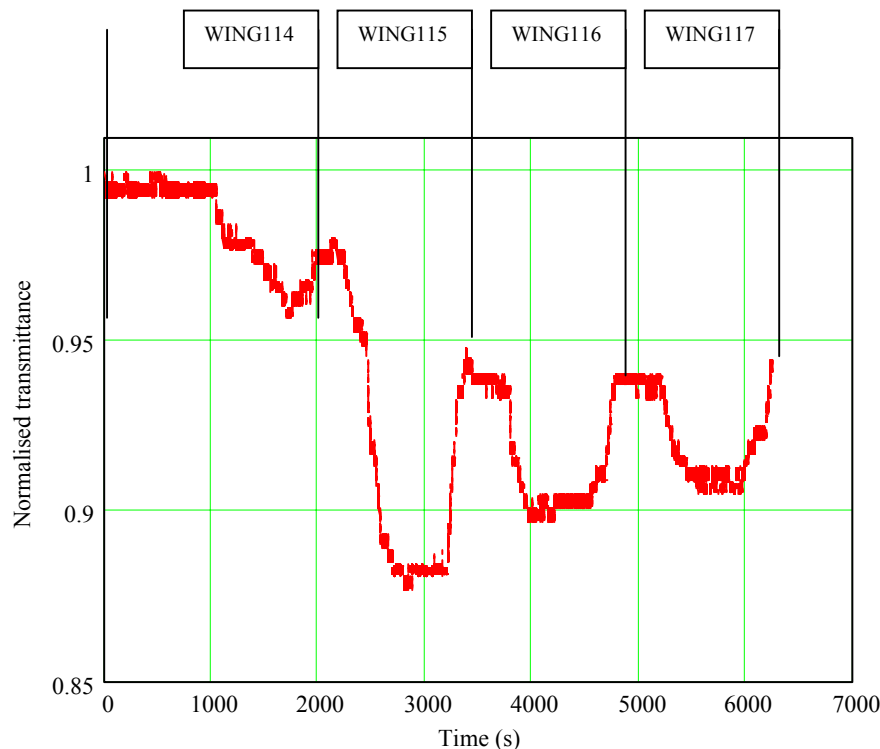
Figure 66. Micro bend transducer signal during WING114- WING117.

The variation of the transmittance through all 4 tests is displayed in Figure 66. The normalised transmittance is here defined as the ratio between the power and the largest power in all four series. The maximum decrease in transmittance was 12.3%, which corresponds to a deformation of the transducer of  $12.3\% / (0.5\% / \mu\text{m}) = 25\text{ }\mu\text{m}$ . The first deformation is apparently irreversible and the initial transmittance was not reached again. This agrees well with the circumstance that the transducer permanently loosened most of its contact to one of the shells.

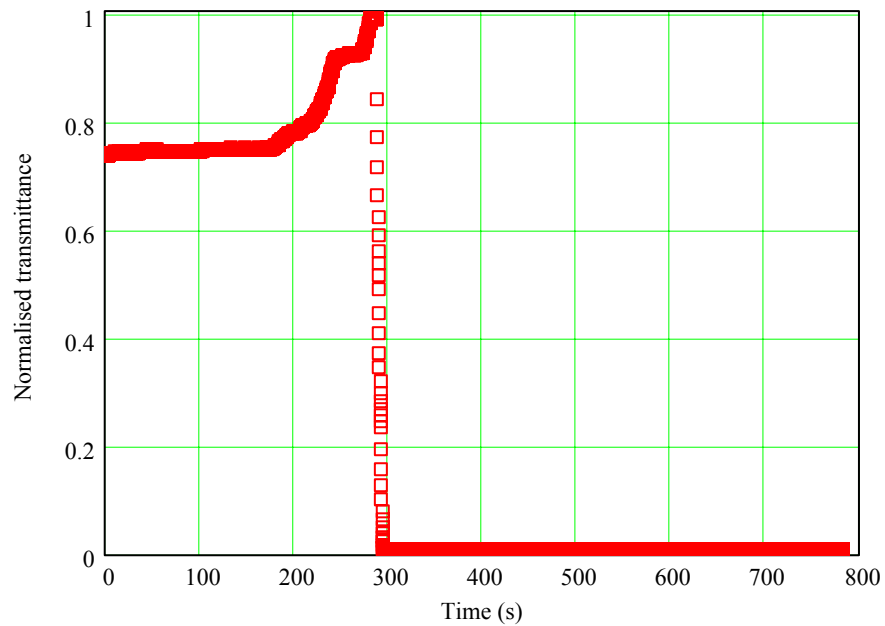
Figure 67. Change in transmittance during WING118.

As Figure 67 shows there is a small increase in transmittance, after which the transmittance drops to zero over a short period of time. Hereafter the wedge is removed and the load on the yoke nearest the tip is removed. The movement of the wedge and the unloading of the blade did not change the transmittance. The fiber is probably squeezed into two or more pieces inside the transducer, because all will be carried by the optical fiber, when the deformation of the transducer is more than 200  $\mu\text{m}$ .
